ENGINEERING SEISMO-GEOLOGICAL JUSTIFICATION OF THE BAYIL LANDSLIDE IN 2018

Determining the contours of a probable landslide-prone territory based on the method of engineering seismic exploration and studying the deep structure of fractured environment.

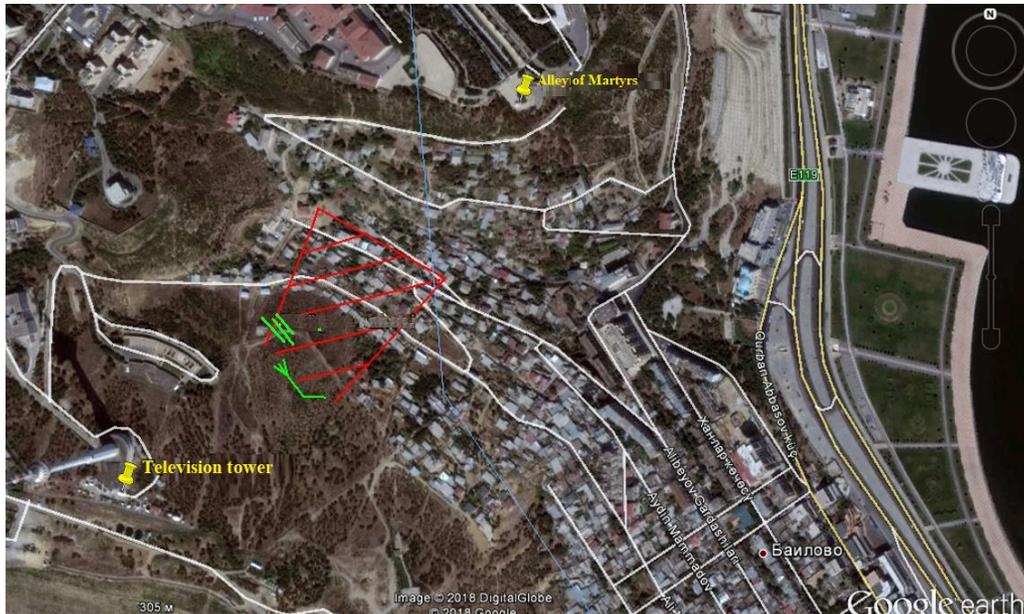
Figure 1. General view of the landslide with observed main fractures in the area

- cracks observed in the area,

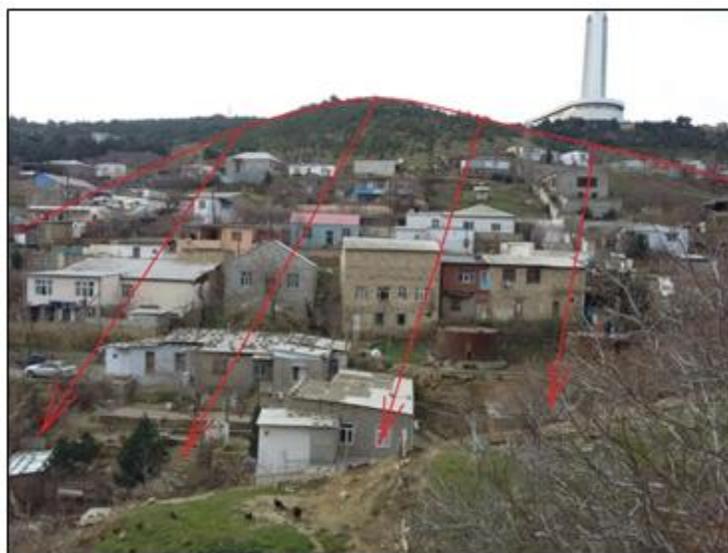
Figure 2. View of houses in the affected area of the prognosed landslide (width 200 m, length 220 m).

- the direction of the prognosed landslide and the area of landslide affection

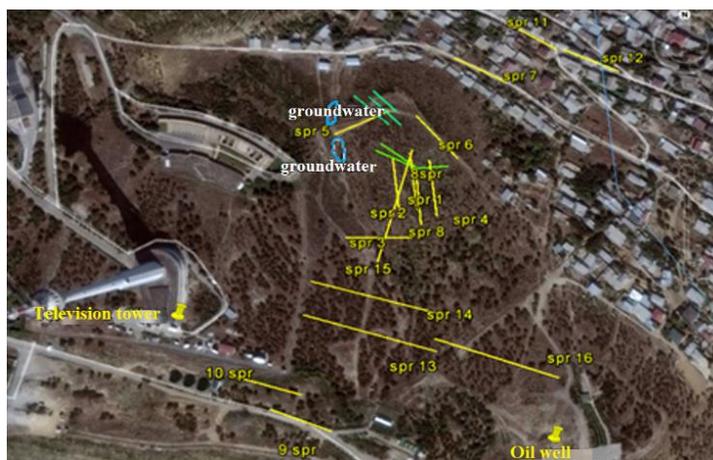
Figure 3. Scheme of seismic profiles in the study area (16 different profiles developed)

16 seismic profiles were built and processed in the area. Profiles 1, 2, 4, 5, 6 and 15 were constructed by cutting through the fractured zone observed in the area. Profiles № 1÷12 have a length of 55 m, and profiles № 13÷16 - 115 m.

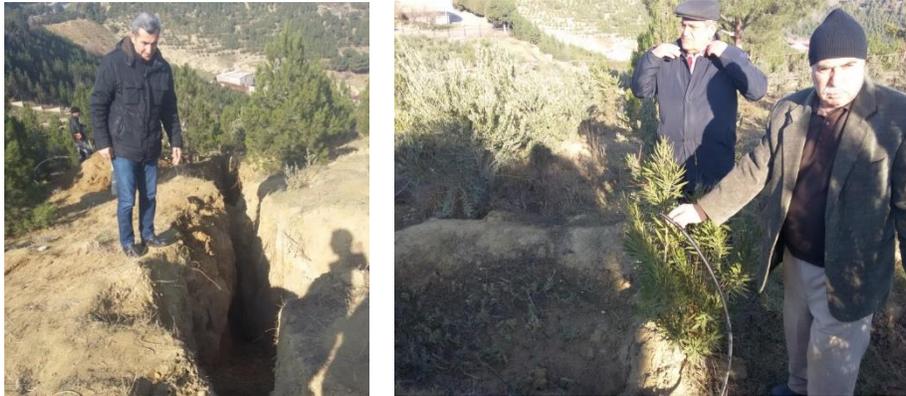
Before the start of the study, the site was visually inspected and a number of anthropogenic interventions affecting landslide activation were noted. These include the cutting of a slope in the

form of a terrace for growing tree seedlings and for building houses, as well as the absence of a sewer line in these houses.

Figure 4. Visual observations at the site

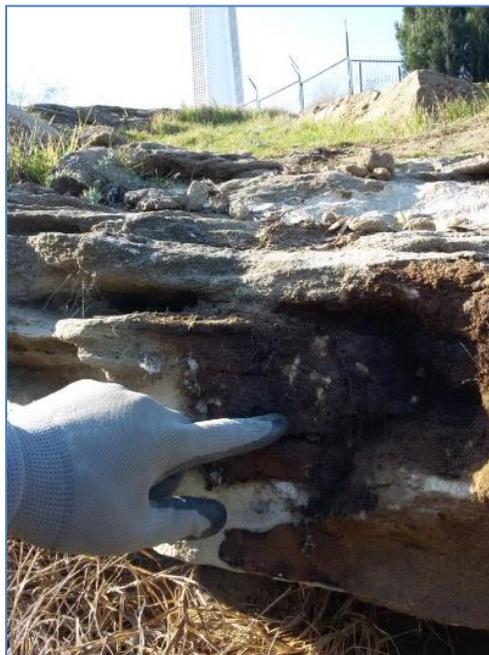
Figure 5. Water leaks in sandstone layers in the northwestern flank of the landslide zone

At the same time, 60-70 m to the north-west of the exploration well at a relative height of 95 m, groundwater leaks were found through sandstone layers, and when sampling soil from a depth of 2 m from the front of the fractured area, clay-loamy soils were found in the form of porridge (Fig. 5, 6).

One of the factors substantiating the reality of landslide risk is the deepening of sandstone layers, where water leaks were observed, under the predicted landslide massif (the area where cracks were observed) and the identification of clay-loamy soils in the form of a porridge on the front of the massif (based on sampling from 2 meter depth).

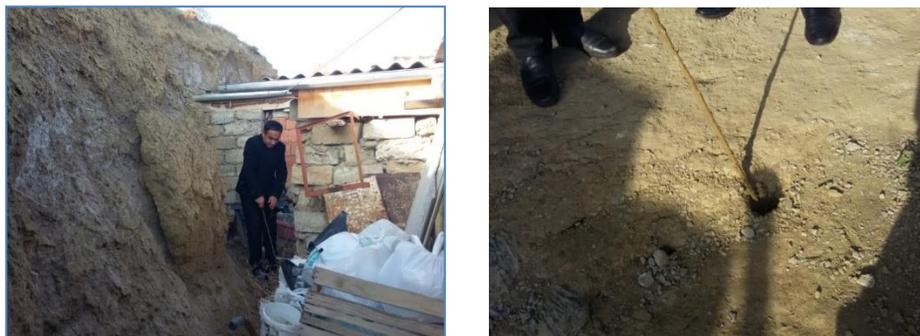
Figure 6. Slope cut in front of the landslide zone and rock sampling from a shallow depth

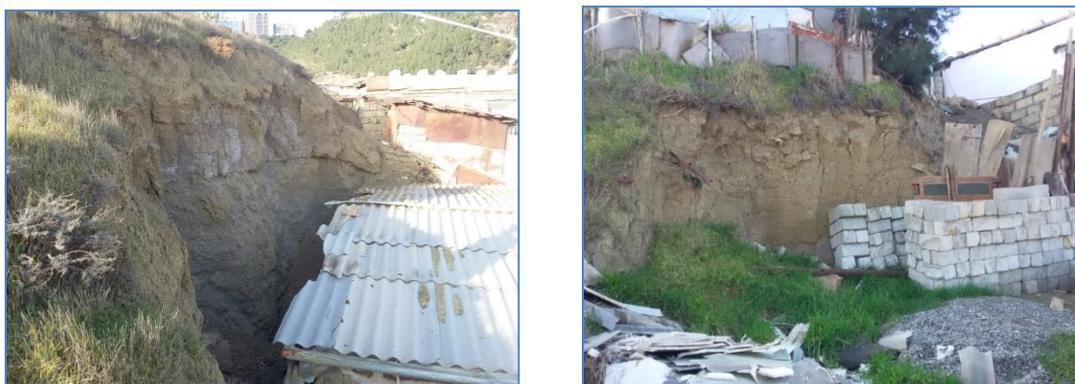
Figure 7. Slope cut in front of the landslide zone

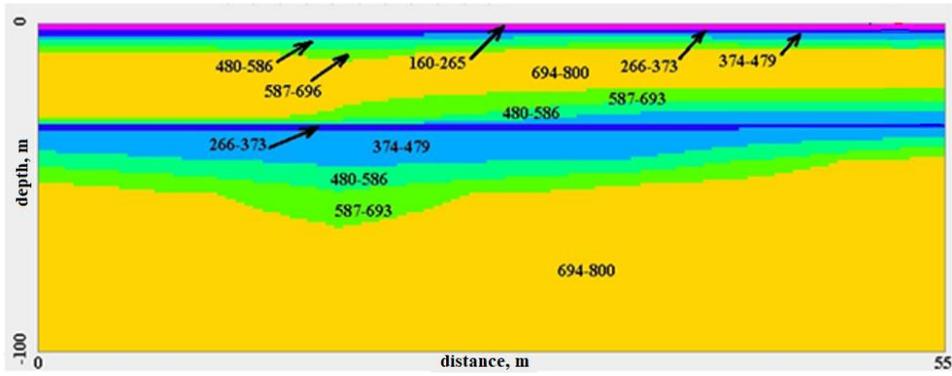
As can be seen from the geological section of the well, the upper lithological section of the study area is composed of a complex of rocks of the Quaternary (Q4) age (semi-hard clays, clastic limestones, fine-grained sands and sandy clays). Sandstone formations are often found among the engineering-geological elements mentioned. Groundwater was not observed during drilling (Fig. 9).

Figure 9. 2D shear wave velocity section on seismic profile №1

According to seismogeological data on seismic profiles № 1, 5 and 6, sandy-argillaceous rock layers were revealed at a depth of 31.5-41.5 m, with a thickness of 10 m and a low wave speed of 350 m/s (on profile 1), 340 m/s (on profile 5), 360 m/s (on profile 6) and at a depth of 28-44 m, with a thickness of 16 m (on profile 7) with a wave velocity of 360 m/s.

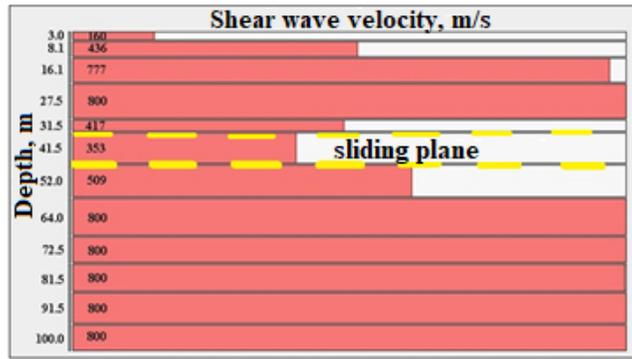
Figure 10. 1D shear wave velocity section on seismic profile №1

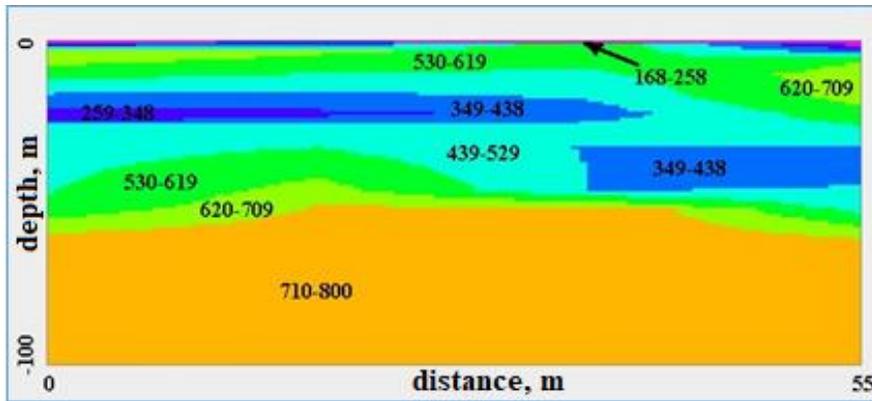
Figure 11. 2D shear wave velocity section on seismic profile №3

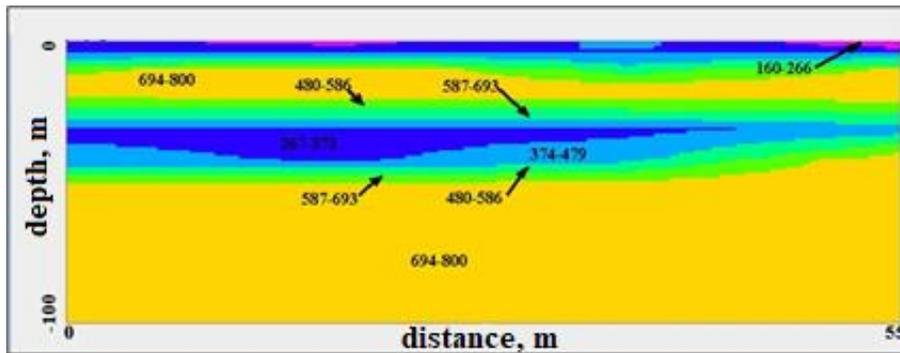
Figure 12. 2D shear wave velocity section on seismic profile №5

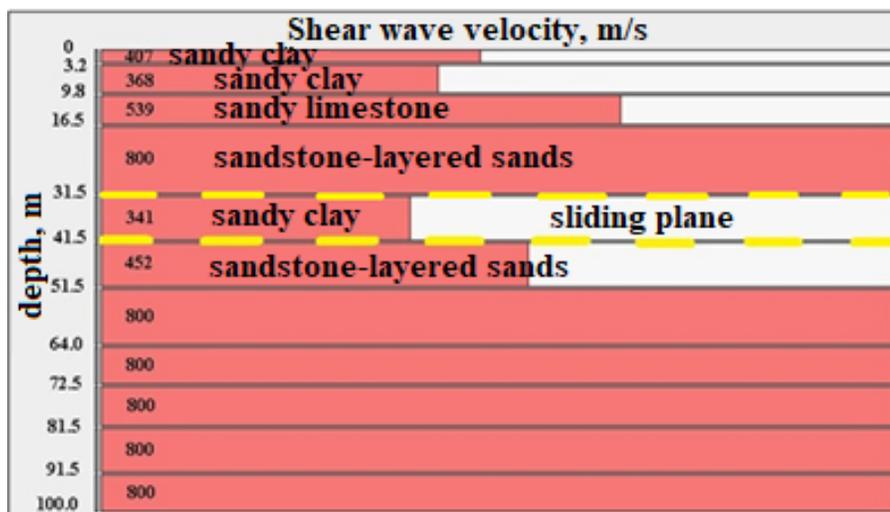
Figure 13. 1D shear wave velocity section on the seismic profile № 5 and seismic georeferencing

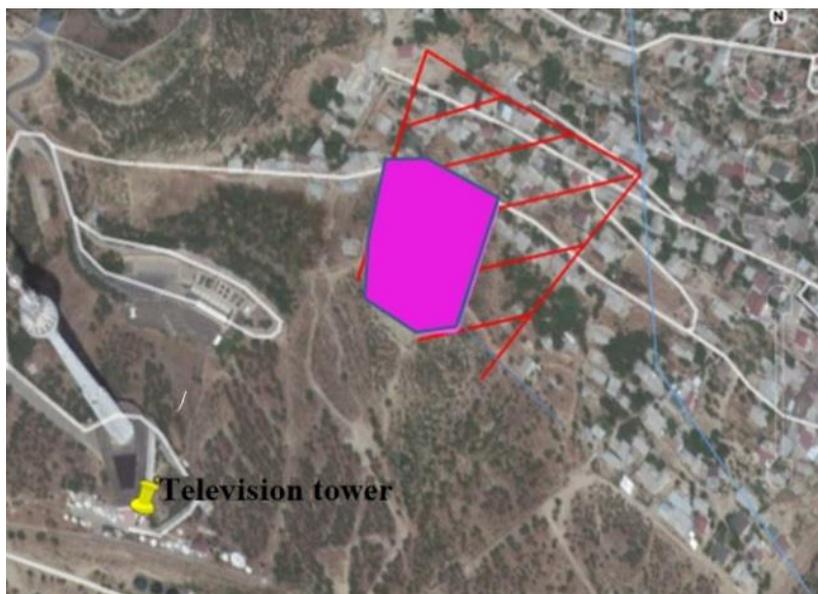
On February 10, 2018, a landslide occurred in the study area, four houses, fences and outbuildings were destroyed, cracks formed in the remaining houses and a very dangerous situation arose (Figure 15-18).

Figure 14. Landslide on February 10, 2018

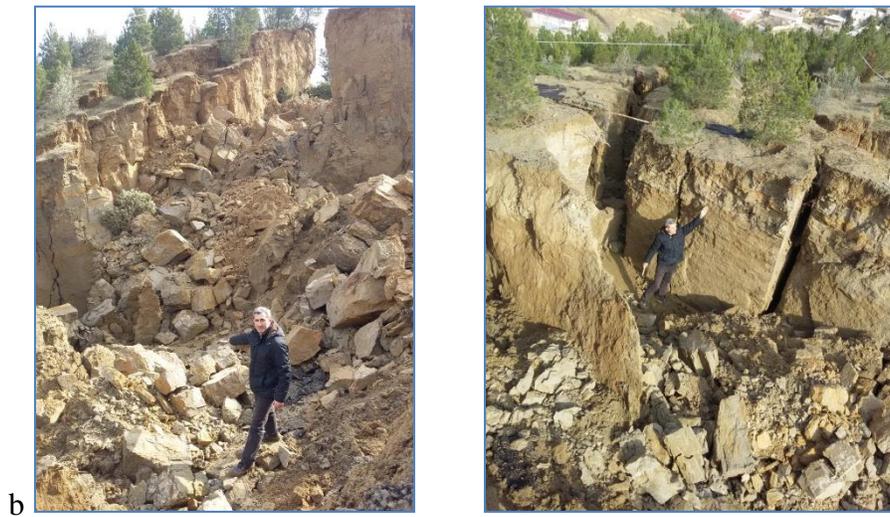
Figure 15. Terrain change observed at a depth of about 10 m at a distance of 19 m at the top of the landslide

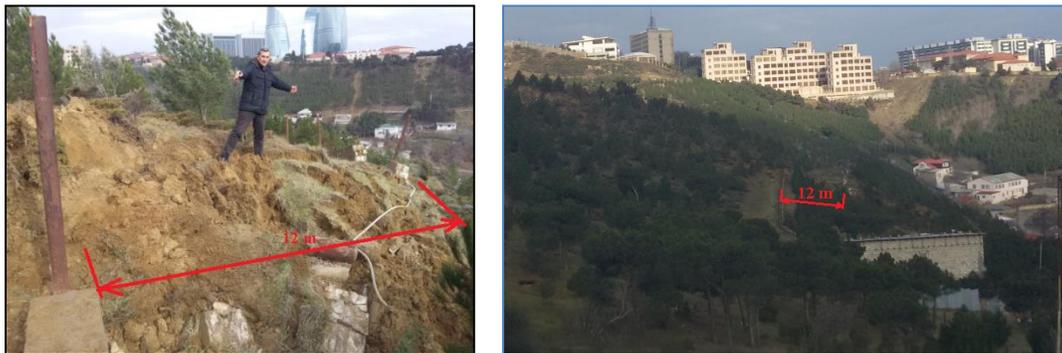
Figure 16. Relocation of a stone fence

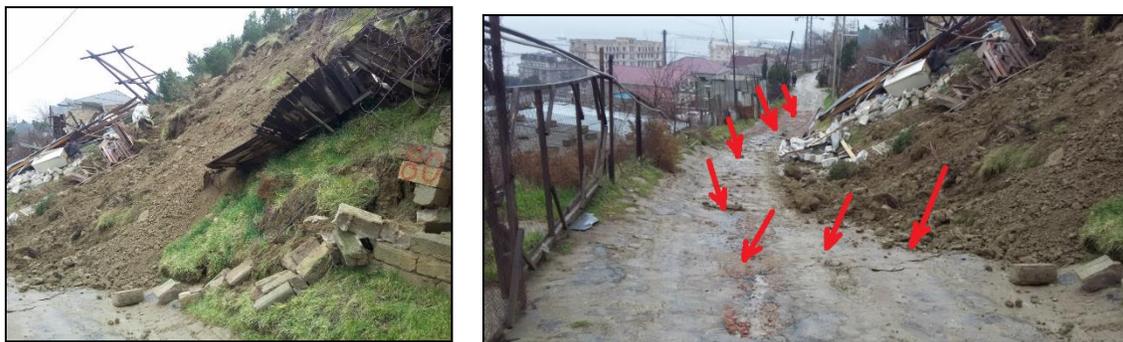
Figure 17. Destruction, observed cracks and uplifts on the surface at a distance of 130 m from the edge of the landslide
